Torrential rains test Corps Big Island flood control projects

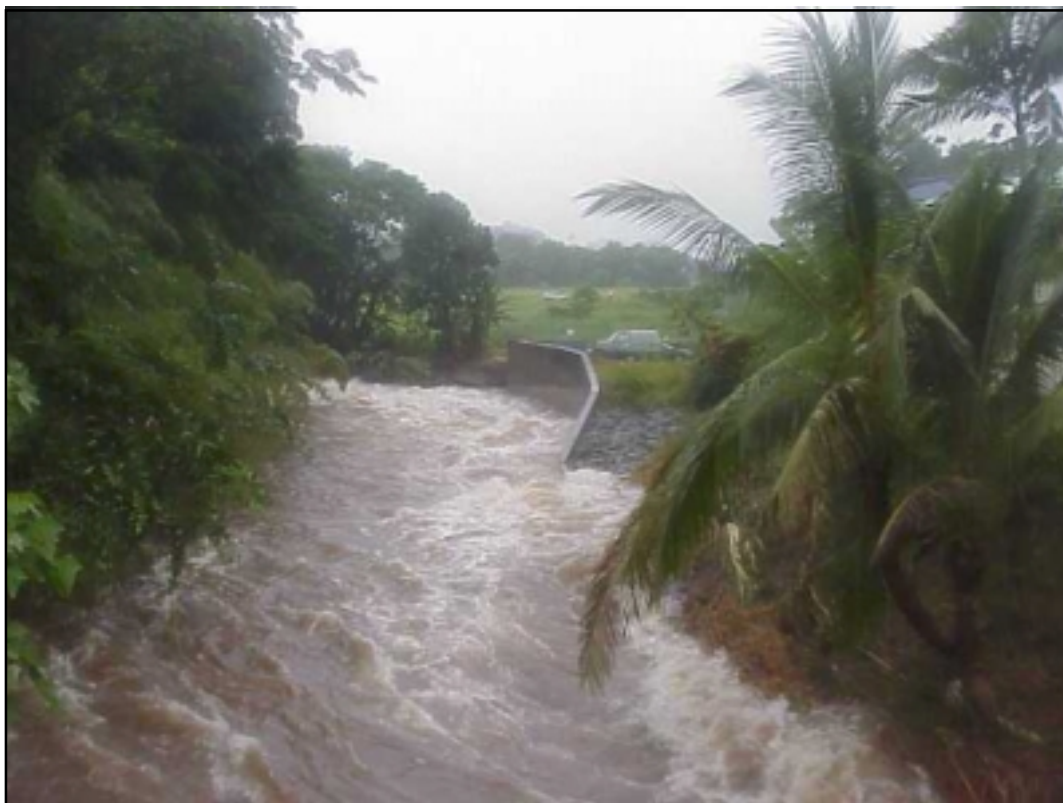
The Alenaio Flood Control Project is functioning near capacity carrying a torrent from 37 inches of rain in two days. —Photo by Dan Meyers.

Preliminary estimates by the Corps based on high-water marks in the project site areas and other data indicated that the Alenaio Flood Control Project (FCP), which cost nearly \$16 million when it was completed in 1998, prevented losses estimated at more than \$14 million, and nearly paid for itself during this recent event. The quantity and force of the water was such, however, that Alenaio FCP did not emerge completely unscathed. It sustained erosion damage at various sites along the stream bank throughout the project. Water overtopped the project at one location, but the overflow was contained by an adjacent channel and rapidly returned to the project. Rehabilitation costs for this project will be 100 percent federally funded and are estimated at \$368,000.

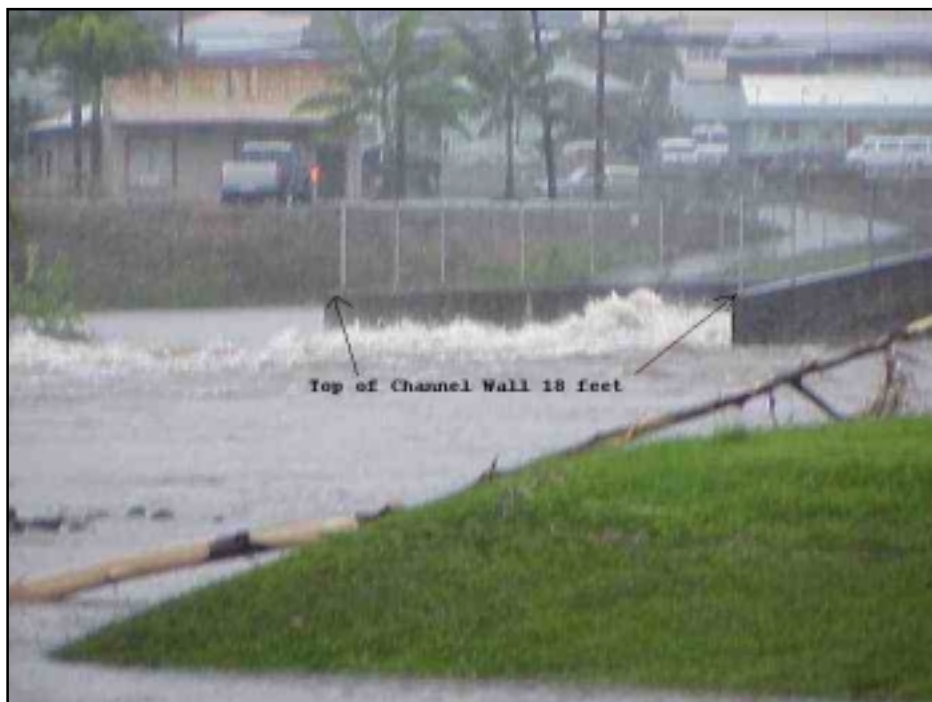
Alenaio Stream outlet showing water level as it exits the flood control project.
